TARGET RESPONSE TO EXPLOSIVE BLAST

Final Report

Falcon Research and Development Company
Denver, Colorado

Contract No. DAHC04-69-C-0095

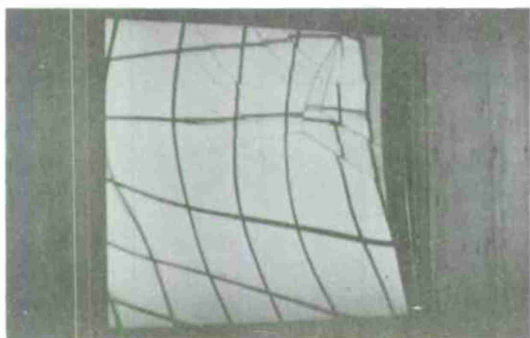
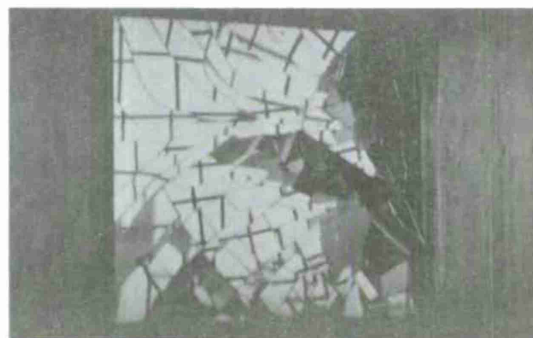
Figure 11. Selected Frames from the Film Record of Window Breakage Taken at 1,000 Frames/Second.

All cameras operated properly on this test and good quality 16-mm photographs of the loading and breakage process were secured. Figures 11 and 12 show series of frames taken from the two film records of the 530-foot window test. These photographs were taken at 1000 and 400 frames per second for Figures 11 and 12 respectively. An analysis of the film records shows that the first cracking of the window took place 35 milliseconds after shock arrival and that the breaking process continued for an additional 10 milliseconds.

The deflection of this window was somewhat more complex than a simple oscillation prior to breakage. The center portion of the window appears to complete a full cycle at about 12 milliseconds after shock arrival; however, the surrounding glass has, at times, moved in different directions than the center of the window. At about +23 milliseconds the left side of the window appears to be well forward of its original position and starting to move in a rearward direction while the right side of the window is beginning to move back from the original position. The total deflection at this point in time is sufficient to allow the right side of the window to escape from the supporting moulding. This would have required a radial deflection of about 3 inches if simple window curvature were assumed. The window continues to be held at the top, bottom and left edges even after the right side escapes from its support. It is interesting that breakage did not occur until twelve more milliseconds elapsed and substantially more window motion had taken place. At breakage, or at least soon thereafter the left side of the window can be seen to be moving forward while the right side is moving backward or into the building.

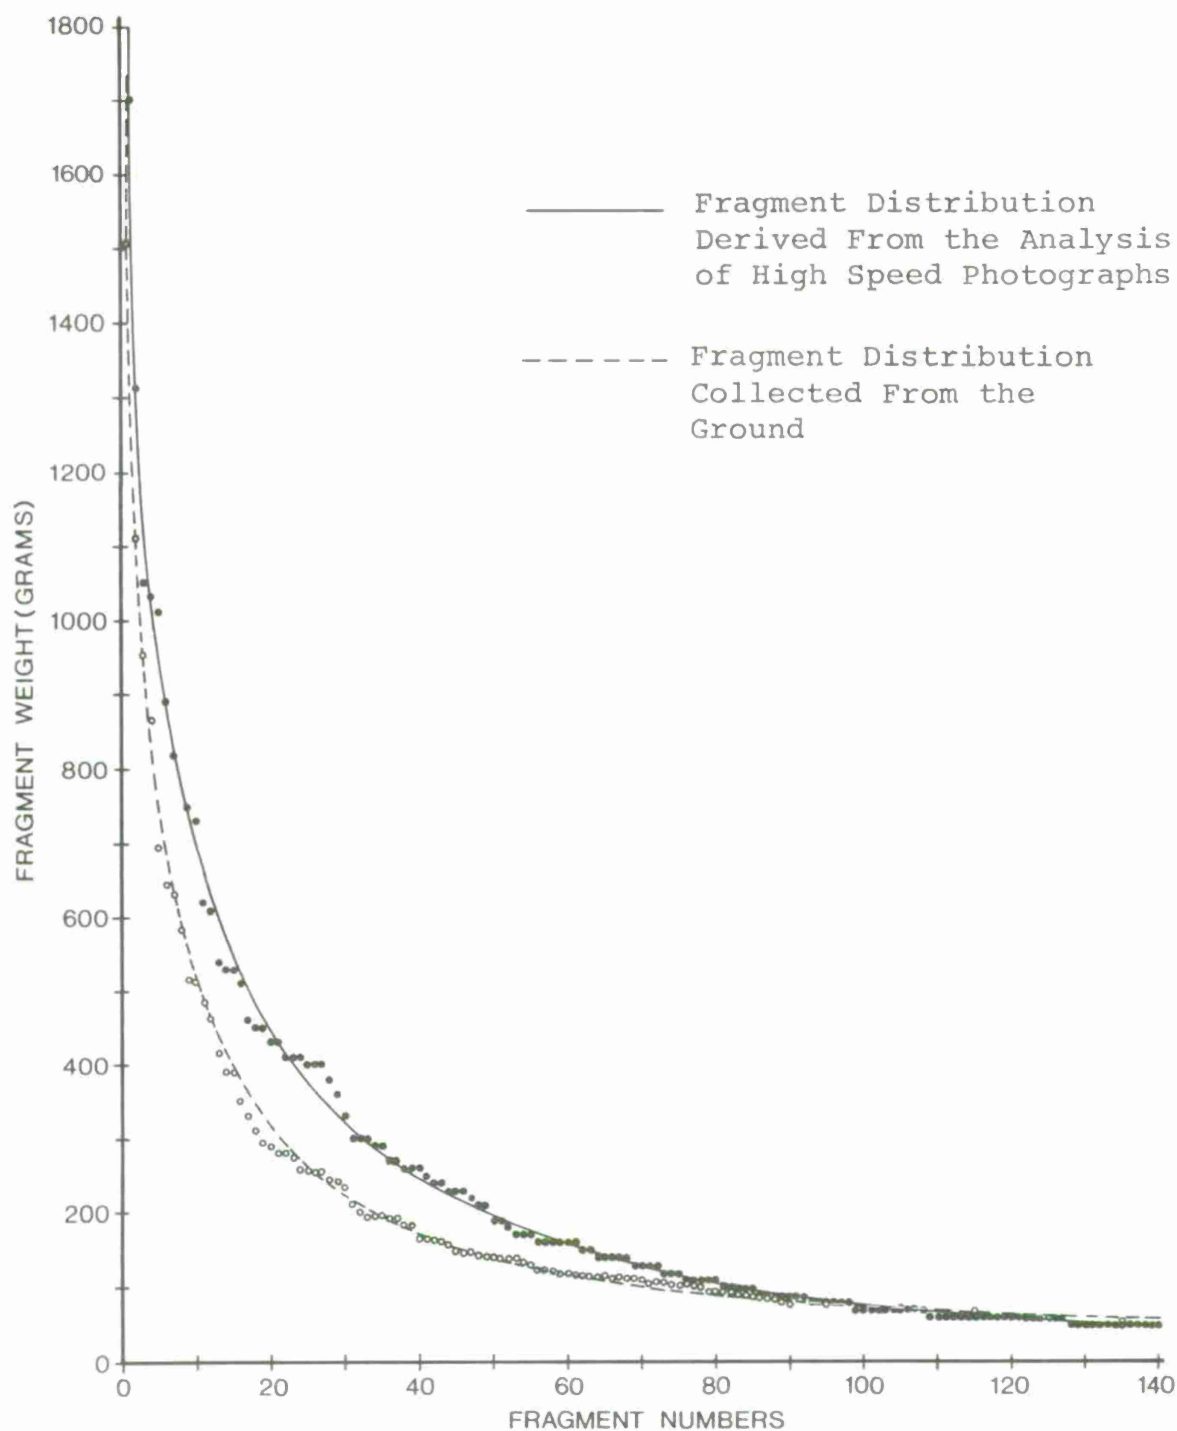
Figure 16. Cumulative Fragment Weight Distributions Produced by Threshold Blast Loading of a 4 Ft. by 6 Ft. Plate Glass Window 1/4 inch Thick.

Figure 16 provides a plot of the data in Tables III and IV. The separation between the two curves must be attributed to secondary breakup of fragments caused by striking the ground or striking other fragments.

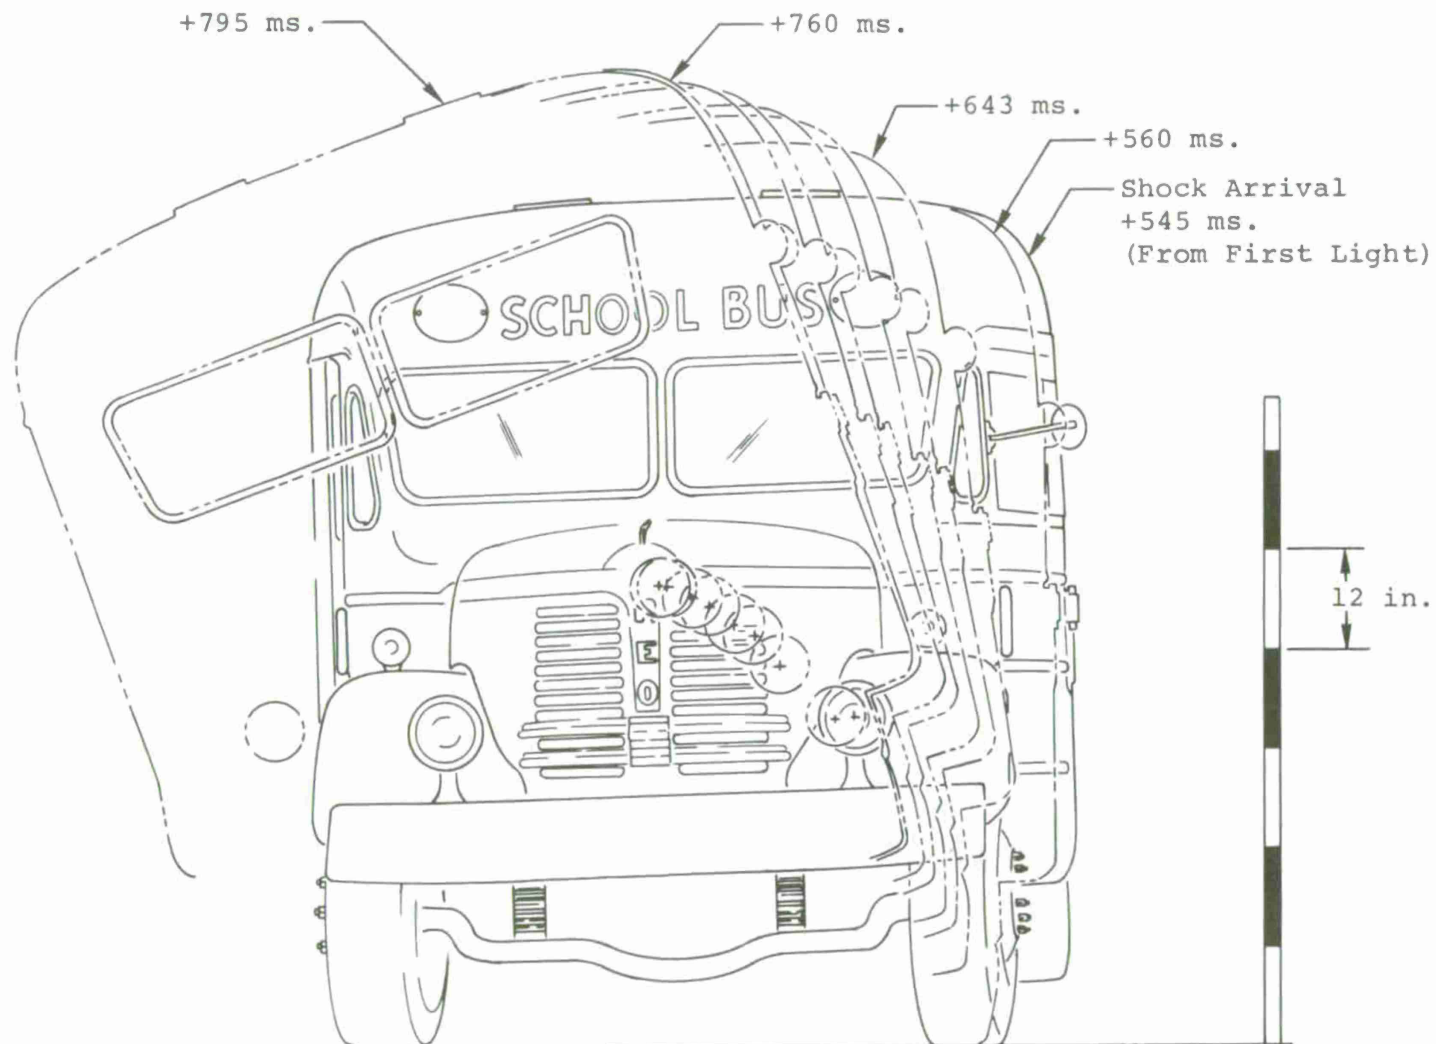
Figure 19. Bus Overturning Motion as Derived From the Analysis of High Speed Photographs.

The film from this location was processed and the results analyzed to produce the evidence of overturning shown in Figure 19.

An examination of the rotation of the bus as shown in the high speed films (summarized in Figure 19) indicates that 60 to 30 percent of the work needed to overturn the bus was completed. The center of gravity was lifted approximately two thirds of the total rise needed for overturning. Thus one conclusion which might be drawn from these data would be that the suspension system of this bus absorbed about one third of the impulse delivered to it and consequently the estimate of impulse needed for overturning should have been proportionately higher. While these data may not be sufficient to accurately determine such a factor, they do clearly indicate that more impulse was needed to complete the overturning. The needed additional impulse must have been at least an additional 80 psi-ms since no more than 80 percent of the required work has been done at a time near the end of the loading curve when the maximum delivered impulse was 315 psi-ms. Similarly the additional impulse needed must be no more than 200 psi-ms since at least 60 percent of the required work was accomplished. The total required impulse for this vehicle is thus bracketed between approximately 400 and 500 psi-ms.

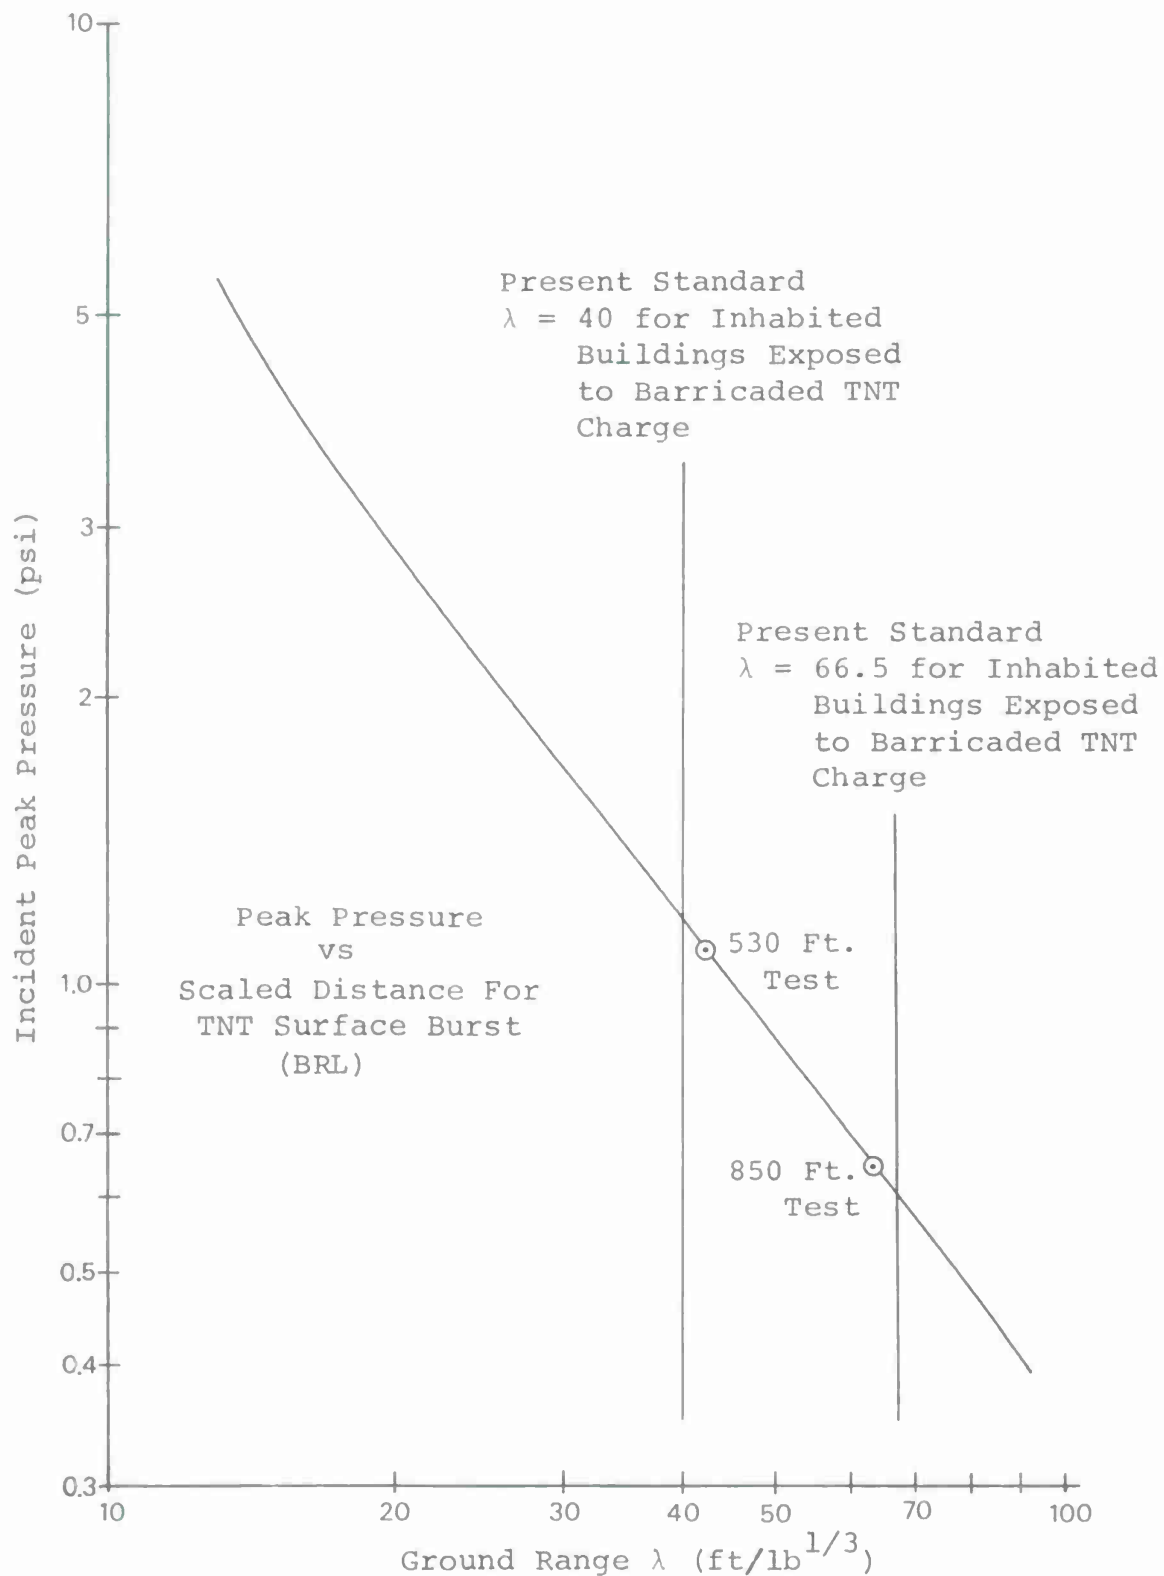
Figure 24. Plate Glass Window Exposures of the Dial Pack Directed Blast Test.

The incident peak pressure to which this window was subjected was determined to be 1.09 psi and the incident impulse 26.94 psi-ms. These data were secured from a BRL self recording gage located at the ground surface and to the side of the building. At the 850-foot location where the window was undamaged, the peak pressure was measured as 0.65 psi and the impulse was 18.46 psi-ms. The reflected pressure levels to which these windows were subjected were 2.26 psi and 1.33 psi respectively. Positive duration at the 530-foot site was 52 ms and at the 850-foot site, 65 ms. These window exposure are summarized in Figure 24.

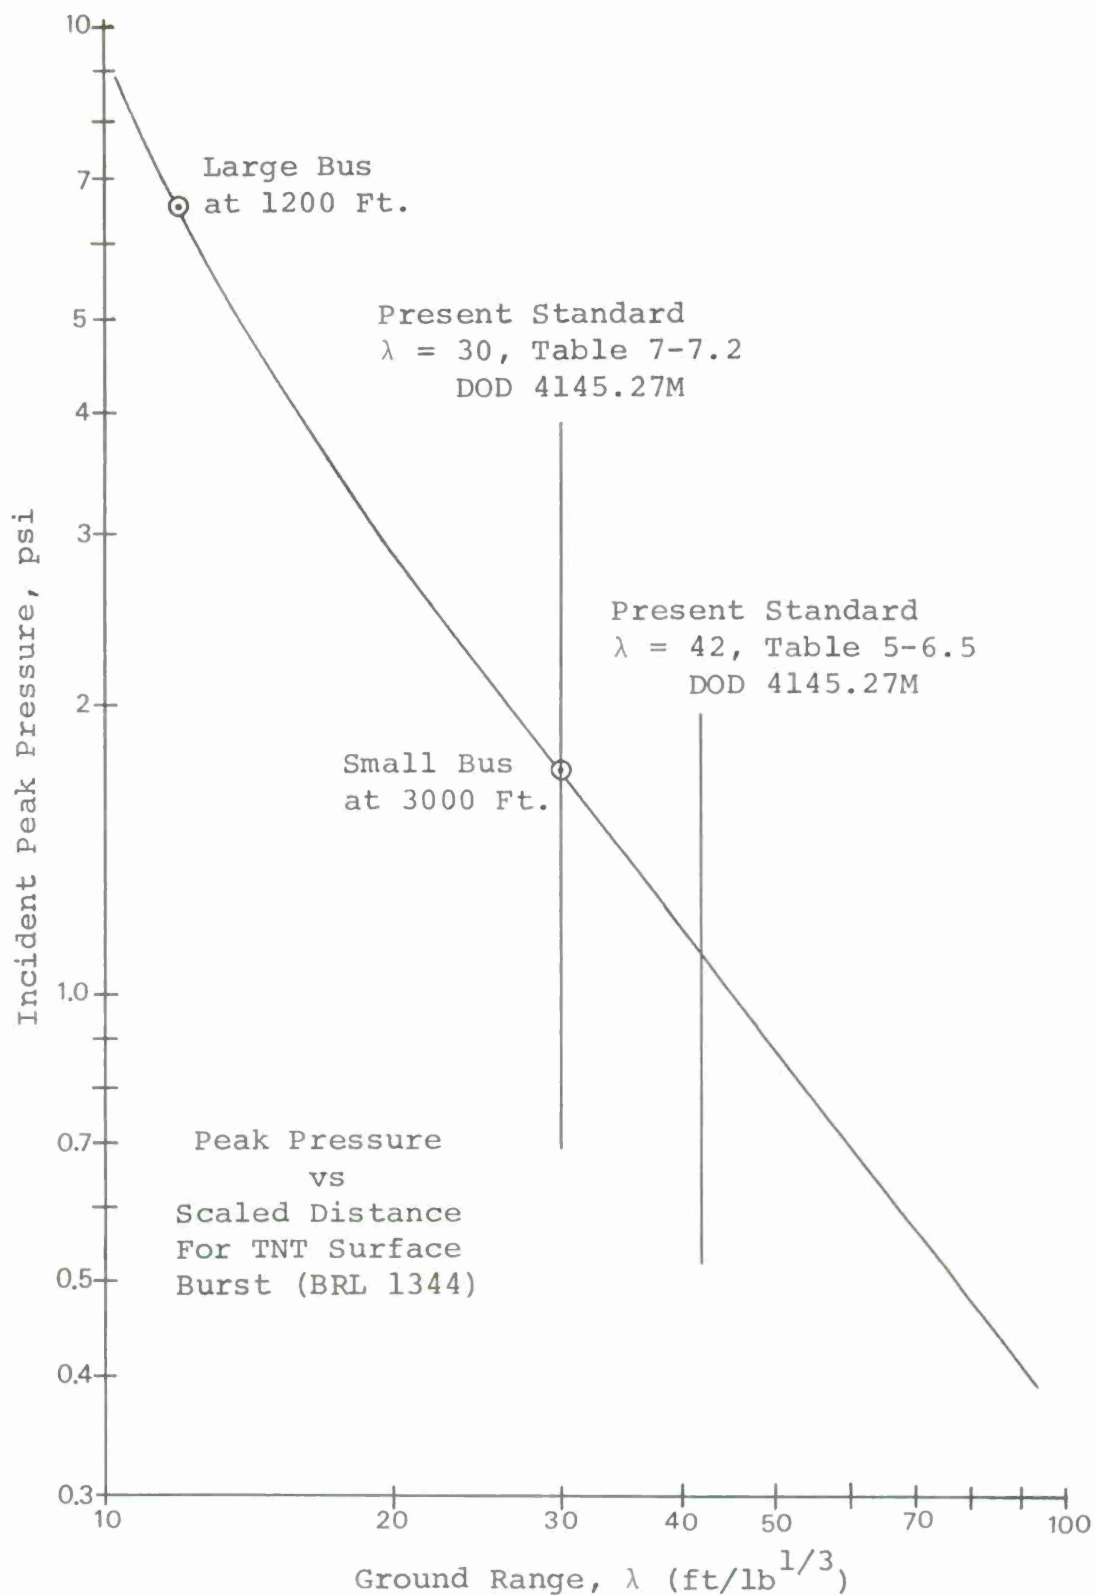
Figure 25. Bus Vehicle Exposures in the Dial Pack 500 Ton TNT test.

The results obtained in these tests of vehicle response to blast indicate that overturning is less of a hazard to large vehicles such as buses than had been predicted by early estimates. Overturning is still more of a threat, however, than a significant lateral motion. The exposure conditions for the buses in the Dial Pack 500 ton TNT test are summarized in Figure 25.

Two modifications to the model of blast interaction with a bus are needed to accurately reflect the behavior of the bus in response to blast loading. First the window area should be subtracted from the effective side area of the bus since the windows fail soon after shock arrival and do not transmit the energy they receive to the body of the bus effectively. The windows of the large bus were broken and moving out of their frames by 20 ms after shock arrival. The large windows of the small bus failed similarly. Second, some factor repre-

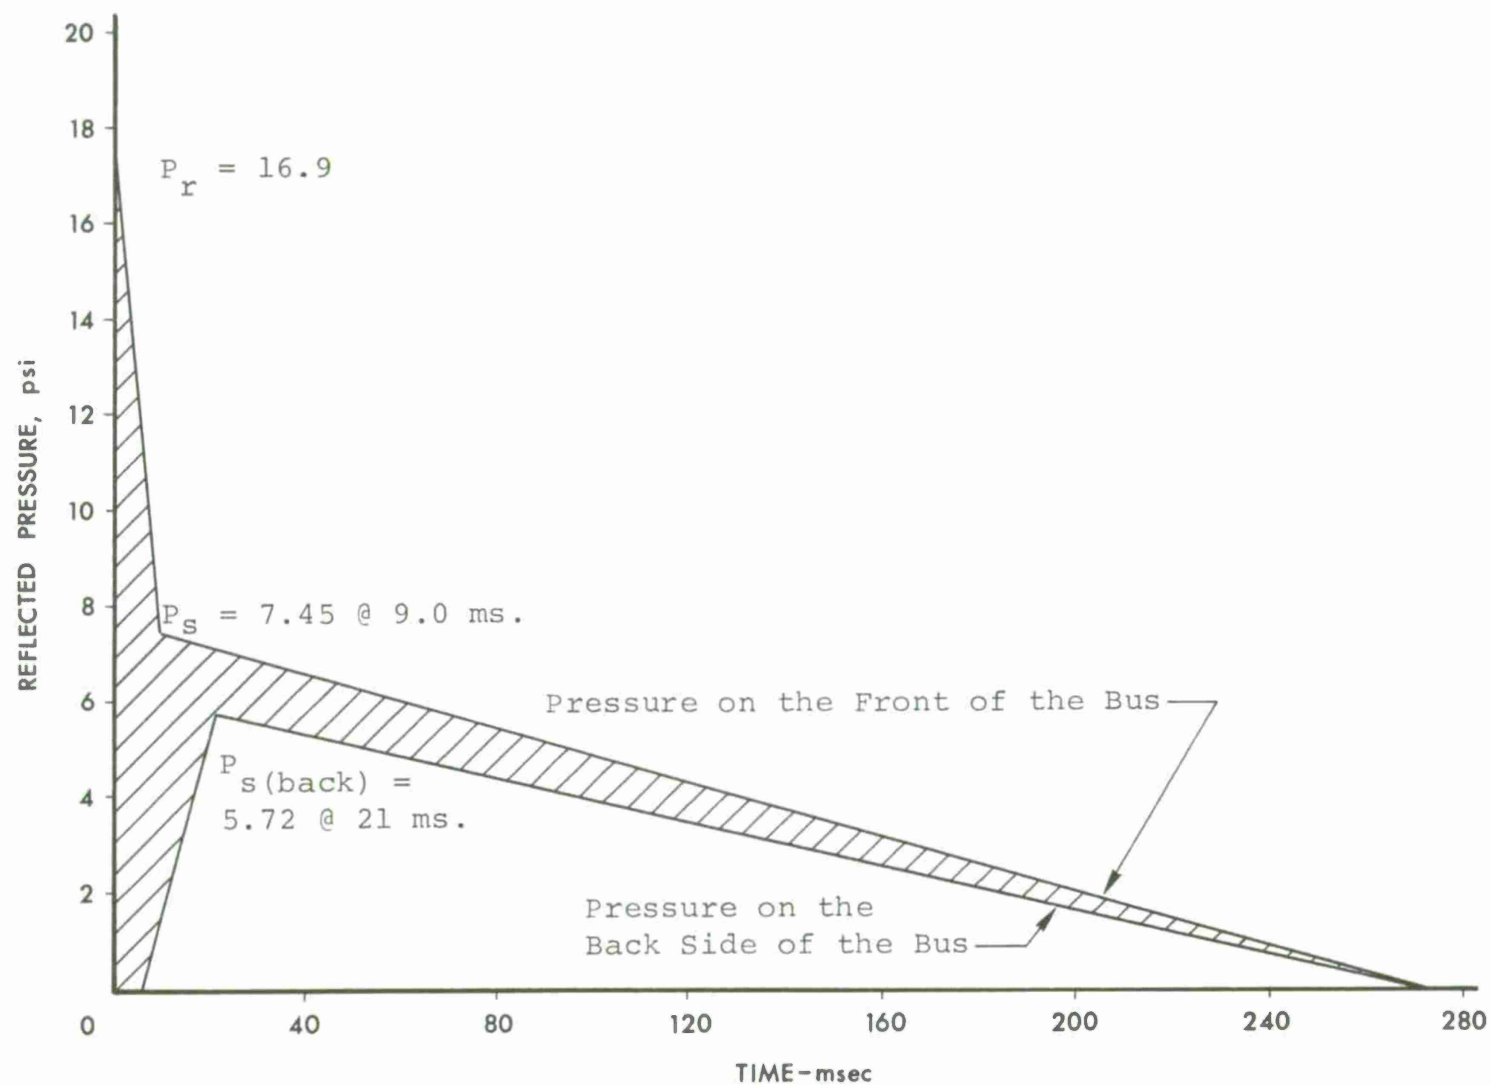
Figure 26. Loading Diagram for the Large Bus Exposed at 1200 Feet From the 500 Ton Charge.

A revised estimate of the impulse which was needed to overturn the large bus of the Dial Pack test, based upon the elimination of window areas from effective side surface, indicates that 250 psi-ms would be required if the bus overturned as a single unit. Figure 26 shows the assumed loading diagram for this vehicle. Only front and rear loading have been considered. This diagram does not include an influence for top and bottom pressure effects or for loading of internal surfaces through broken windows. The total net impulse derived from this loading diagram is 315 psi-ms. About half of this is available during the first 21 ms and the other half must be delivered during the remaining 250 ms where the pressure differential is quite low.
